## **ENVIRONMENTAL ASSESSMENT AT THE BARONS HARDWARE / SERVICE STATION**

PHASE II  
Subsurface Investigation and De-commissioning Report  
Barons Hardware  
Barons, Alberta

Prepared By:  
George Hasegawa P.Eng.  
Mark Hasegawa

Date: August 13, 1996

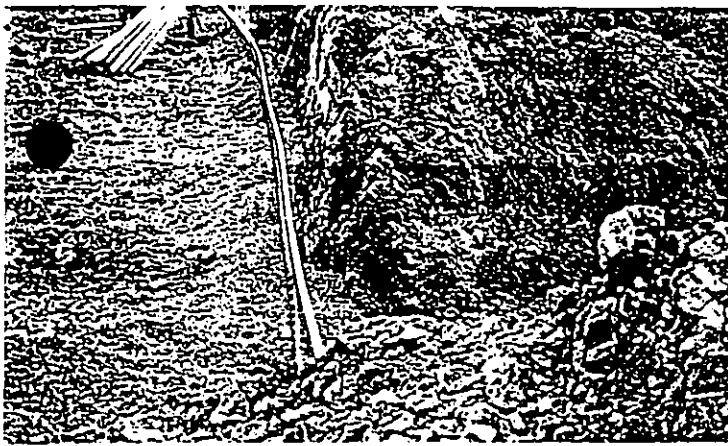
PIPE R/LN NORTH SIDE EXCAVATION

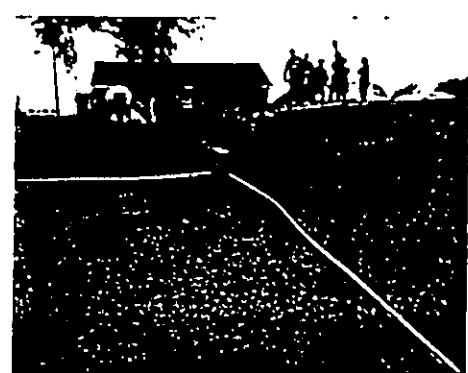
PPE R/LN N.W. CORNER

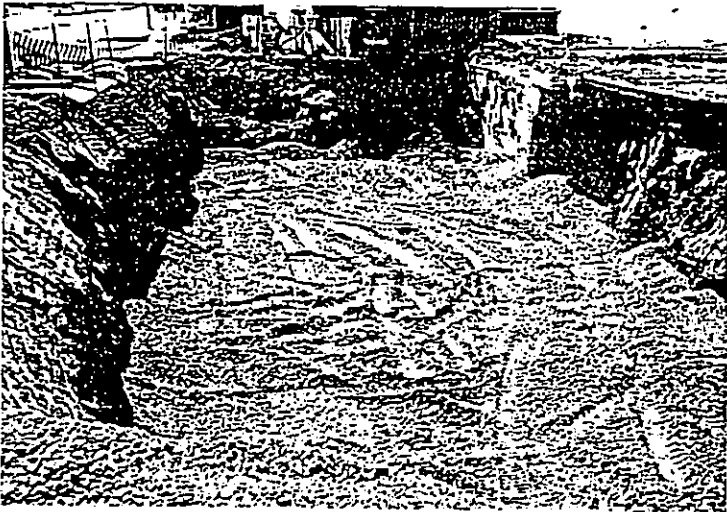
PIT RUN FILL IN CENTER WASHED  
ROCK ON EDGES

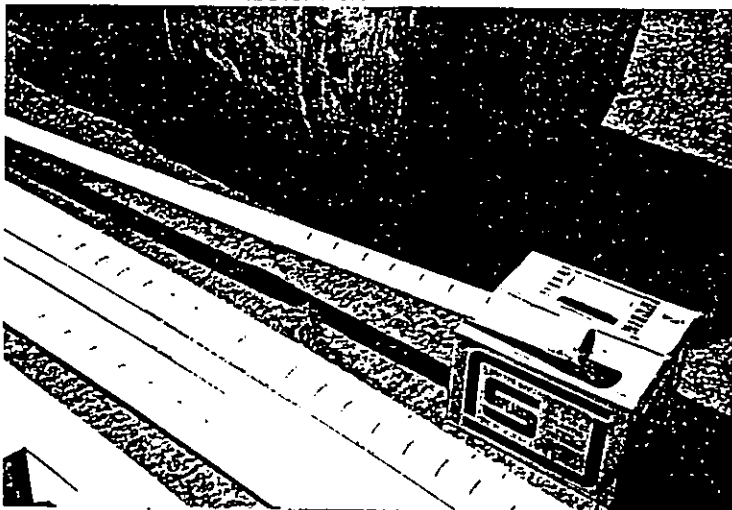
2" PERFORATED PVC PIPE

Prior to backfilling SVE piping was placed in the excavated area. Washed gravel was placed around the perimeter of the excavation. The SVE piping was placed at approximately 3 m deep and consists of 5 zones (refer to appendix A; Figure 2) The remainder of the excavated area was backfilled with gravel and pit run. Soil was replaced in 2 foot lifts and mechanically compacted.
