**INTERPRETIVE REPORT AND  
OUTLINE REMEDIAL ACTION PLAN  
FORMER BARONS TURBO BULK STATION NO. 2520  
235 MAIN STREET  
BARONS, ALBERTA**

**SEACOR Job No. H0031-093**

**Submitted by  
SEACOR Environmental Engineering Inc.  
Calgary, Alberta**

November 13, 1996

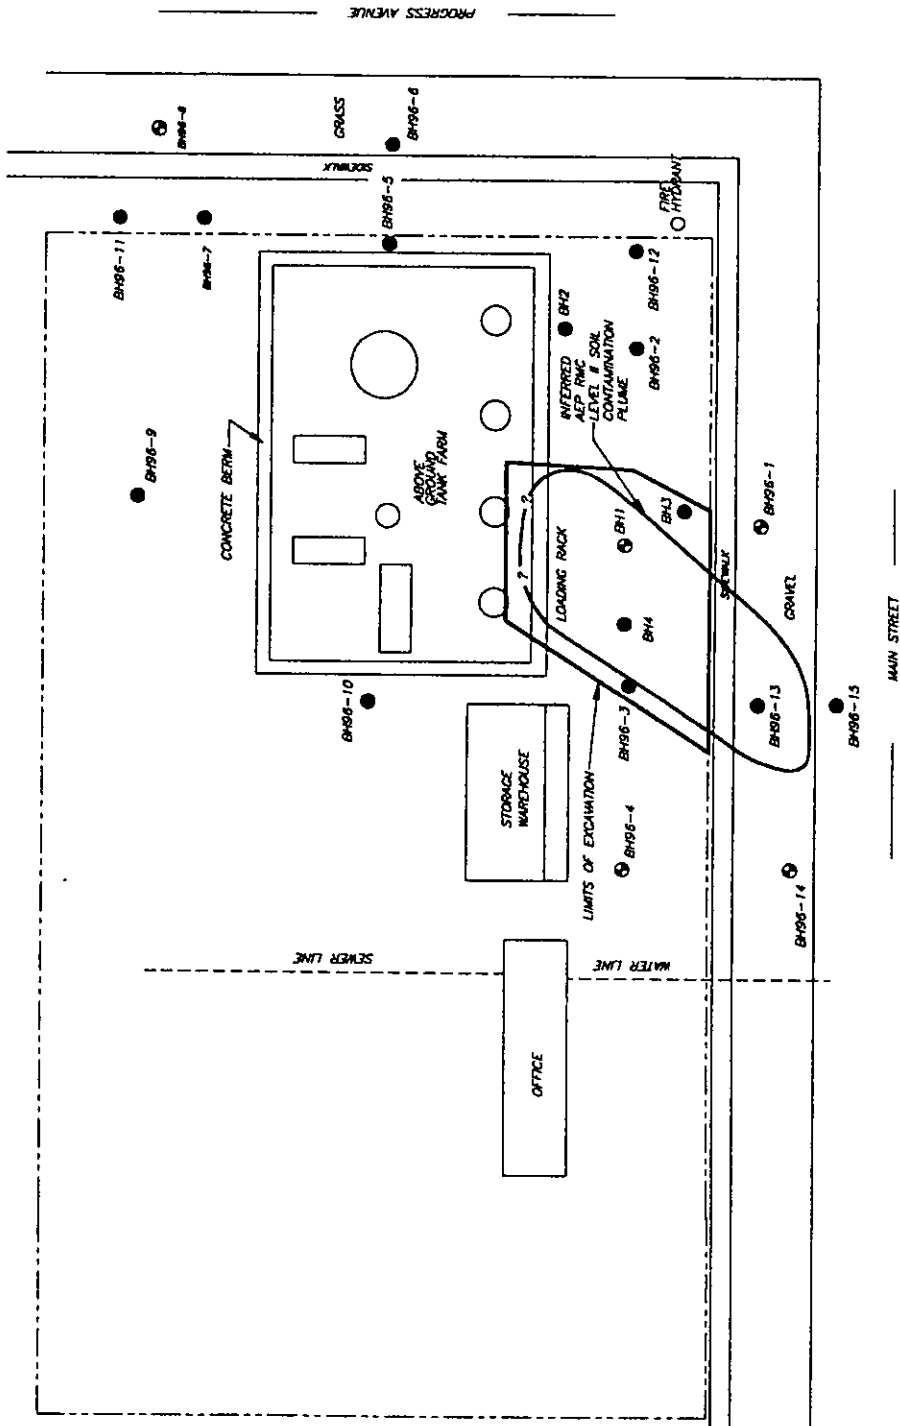
INFERRED SOIL CONTAMINATION PLUME

- The analytical chemistry results indicated hydrocarbon compounds in excess of the AEP RMC *Level II* criteria for fine grained soil (FGS) on-site within the loading rack area at depths of 1.5 to 3.0 m and off-site to the south underneath the Main Street boulevard at depths of 2.7 to 3.2 m below grade. The areal extent of the hydrocarbon contaminant plume is illustrated on Figure 2.

Residual gasoline-based hydrocarbon contamination in excess of the AEP RMC *Level II* FGS criteria is present within the fill and native soil on-site in the loading rack area and off-site to the south underneath the Main Street boulevard. The hydrocarbon contamination in the loading rack area was generally found at depths from 1.5 to 3.0 m below surface grade and off-site at depths of 2.7 to 3.2 m below grade. The inferred AEP RMC *Level II* soil contamination plume is illustrated on Figure 2.

An estimated 200 m<sup>3</sup> (in place volume) of impacted soil (native clay and clay till) is present on-site in excess of the AEP RMC *Level II* criteria and a further 50 m<sup>3</sup> is estimated off-site underneath the Main Street Boulevard.

- Removal of the aboveground storage tanks and associated equipment.
- Surface stripping and stockpiling of approximately 200 m<sup>3</sup> of clean overburden fill and over-excavation of impacted soil to a maximum depth of 3.2 m (or as determined by soil vapour testing).
- Off-site removal of an estimated 200 m<sup>3</sup> (400 tonnes) of impacted soil to the Lethbridge Regional Landfill.
- Backfill with clean compacted backfill and stockpiled clean fill.

An estimated volume (200 m<sup>3</sup>) of clean soils in the loading rack and tank farm areas will be excavated to a depth determined by headspace vapour testing and stockpiled on-site for subsequent backfilling. The impacted soils will be excavated to maximum depths of 3.0 m or as determined by headspace vapour testing and disposed of off-site. Soil samples will be field screened by SEACOR and laboratory analyzed to confirm that an acceptable level of clean-up has been achieved. The excavation stability should be reviewed by a qualified professional geotechnical engineer during the excavation due to the potential for wall collapse, particularly along the south property lines. The impacted soils will be landfilled at the Lethbridge Regional landfill. The excavated areas will be backfilled, with both clean fill and stockpiled soils, and compacted.
