VILLAGE OF BARONS

UNDERGROUND STORAGE TANK REMOVAL AND MONITORING 202 MAIN STREET BARONS, ALBERTA ALBERTA MUNICIPAL AFFAIRS SITE #9557

REPORT

OCTOBER 2013
ISSUED FOR USE
EBA FILE: L22103112-01

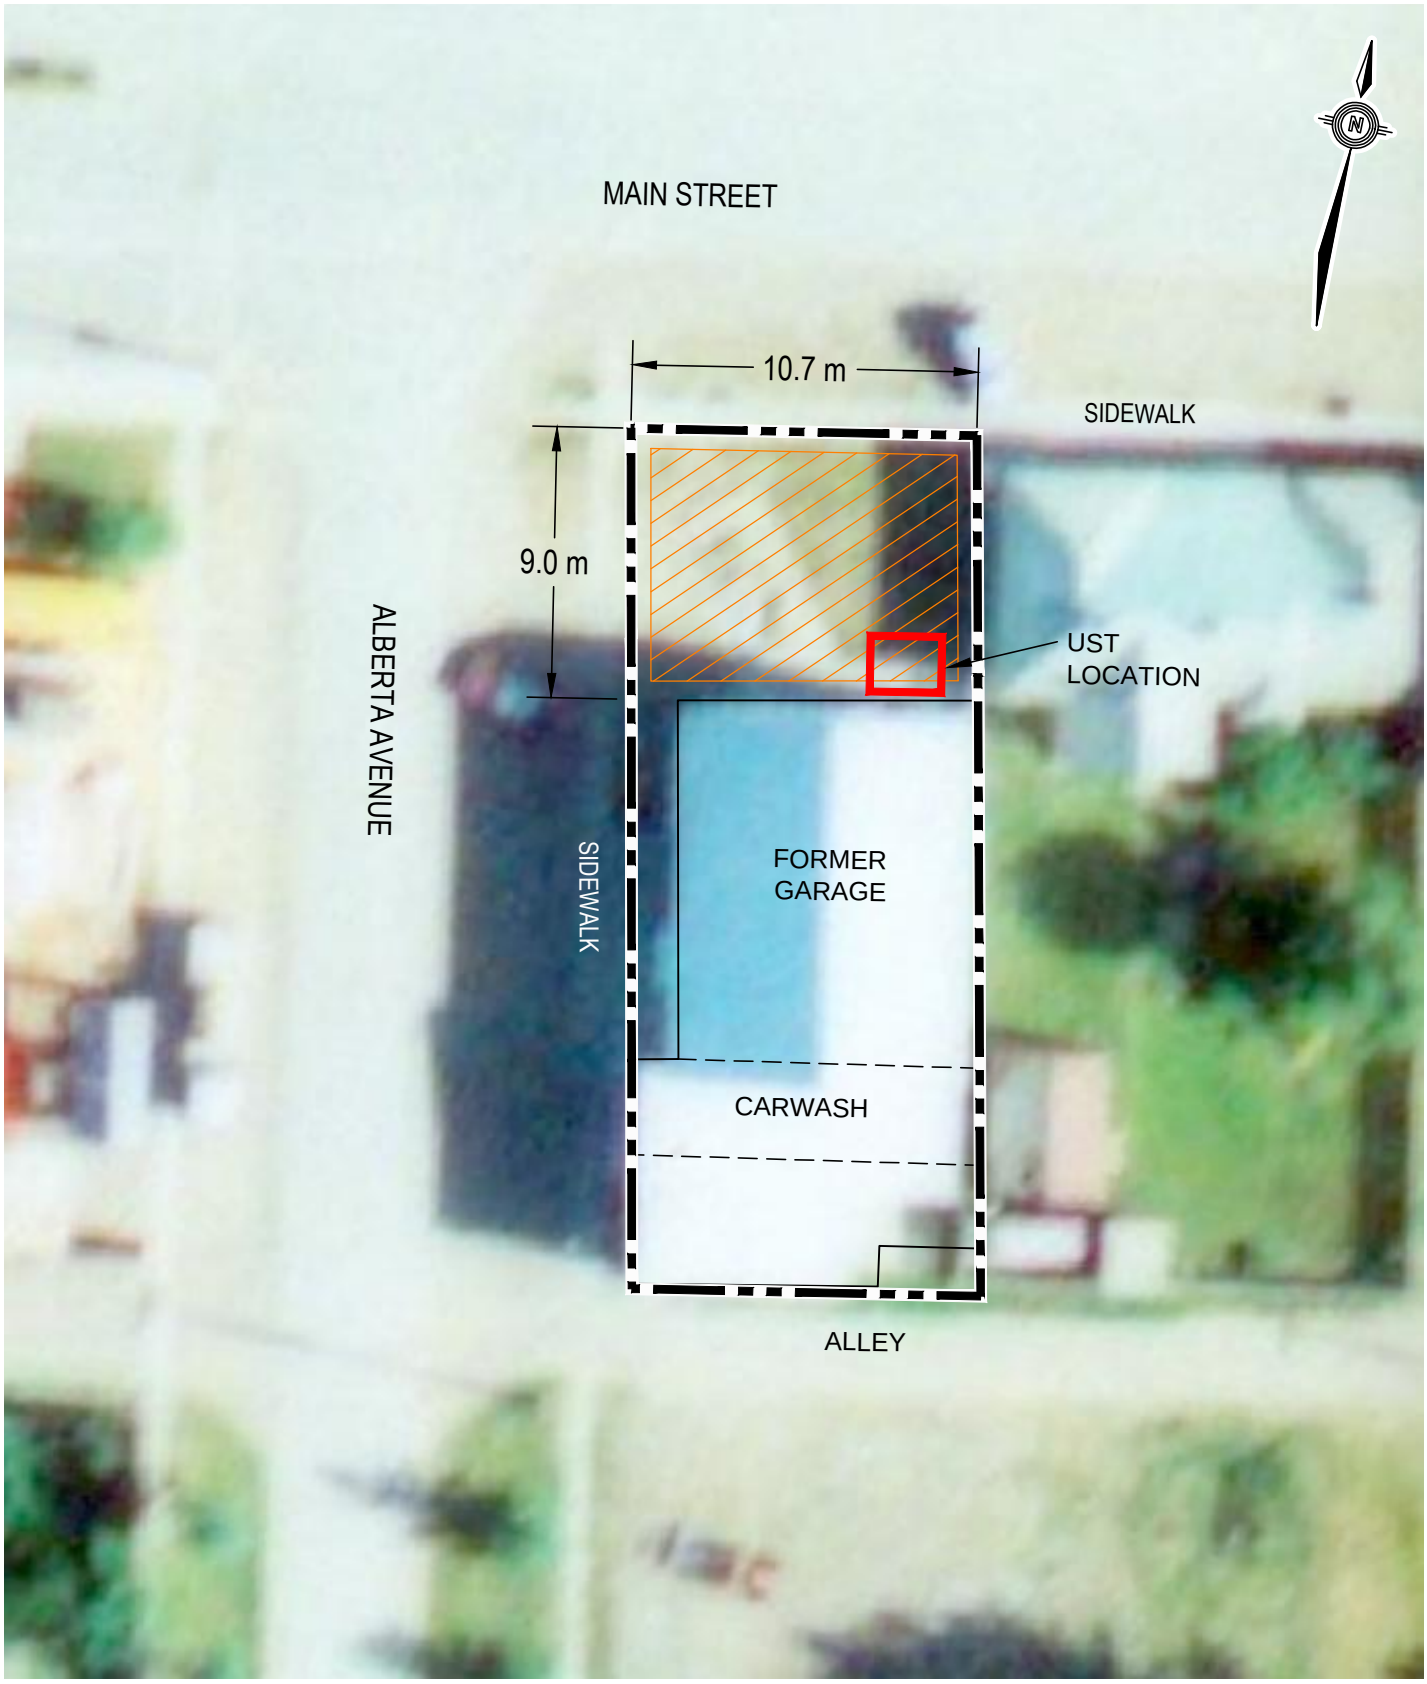
Figure 2

The boundaries of the excavation were limited due to urban infrastructure (Figure 2). The north and west boundaries of the excavation were established by existing sidewalks and roadways, and the south and east excavation limits were bound by existing buildings.
