**INTERPRETIVE REPORT AND  
OUTLINE REMEDIAL ACTION PLAN  
FORMER BARONS TURBO BULK STATION NO. 2520  
235 MAIN STREET  
BARONS, ALBERTA**

**SEACOR Job No. H0031-093**

**Submitted by  
SEACOR Environmental Engineering Inc.  
Calgary, Alberta**

November 13, 1996

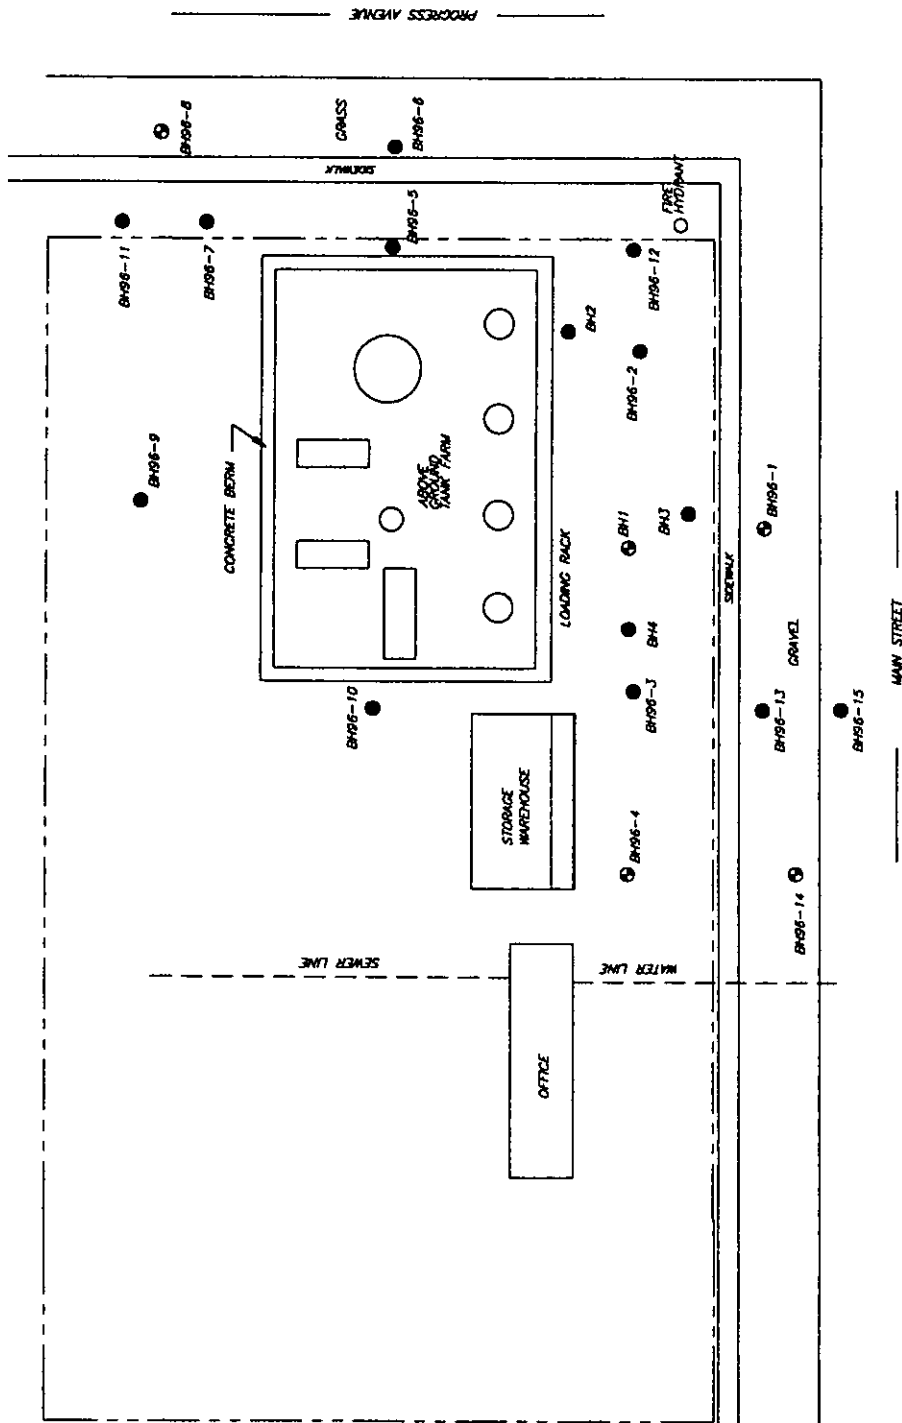
Residual gasoline-based hydrocarbon contamination in excess of the AEP RMC *Level II* FGS criteria is present within the fill and native soil on-site in the loading rack area and off-site to the south underneath the Main Street boulevard. The hydrocarbon contamination in the loading rack area was generally found at depths from 1.5 to 3.0 m below surface grade and off-site at depths of 2.7 to 3.2 m below grade. The inferred AEP RMC *Level II* soil contamination plume is illustrated on Figure 2.
